**Nineteenth United Nations Regional Cartographic
Conference for Asia and the Pacific**

**How the NGIA of Japan responded to the Great East Japan
Earthquake***

Kazushige KAWASE, Japan

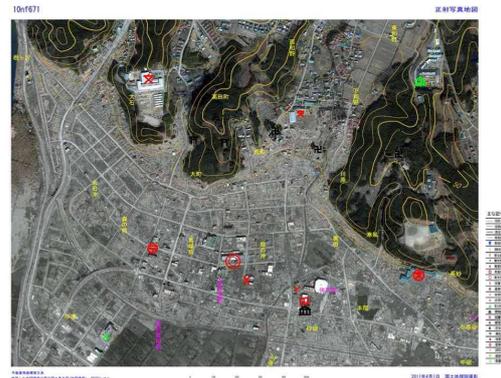
Figure 7 An example of orthophoto map (10NF671), Rikuzen Takada city (GSI 2011e)

Aerial photo products were produced in order series. Firstly, simple photos were made. Then photos were orthorectified using GPS/IMU data on the aircraft. Accordingly orthophotos and orthophotomap (Figure 7) (orthophoto overlain by line map with locality names and symbols) were produced. Orthophoto pairs were also made to show the difference of landscape before and after the earthquake in specific areas (Figure 8). Later bird's

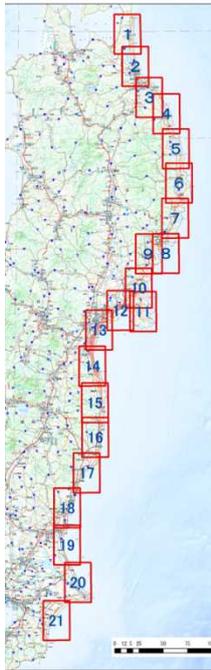
Figure 9 Index of inundation area map (GSI 2011g)

When the first aerial photographs were delivered in the afternoon of 13 March, the team interpreted them to delineate the inundation areas by the tsunami. One thousand nine hundred aerial photos were interpreted to make the first version of inundation map for the delivery to the Cabinet Secretariat and major institutions on 14 March. No sooner had additional aerial photographs of damaged areas arrived, the team interpreted and delineated additional areas. Finally it was found that 561km² was inundated by the tsunami. Half of inundated areas were located in Miyagi prefecture (327km²). Land use map series of inundated areas were also produced to show the character of land use pattern of inundation areas. The index map is shown in Figure 9. Inundation area map is shown in Figure 10. Land use of inundated area is in Figure 11.

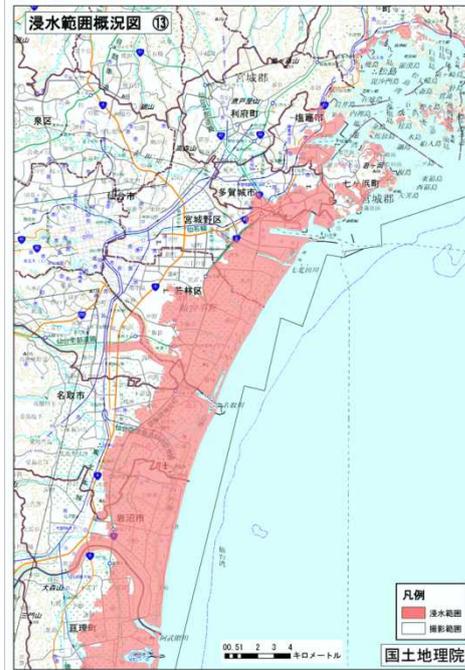
Figure 10 An example of inundation area map, Sendai area (GSI 2011g)

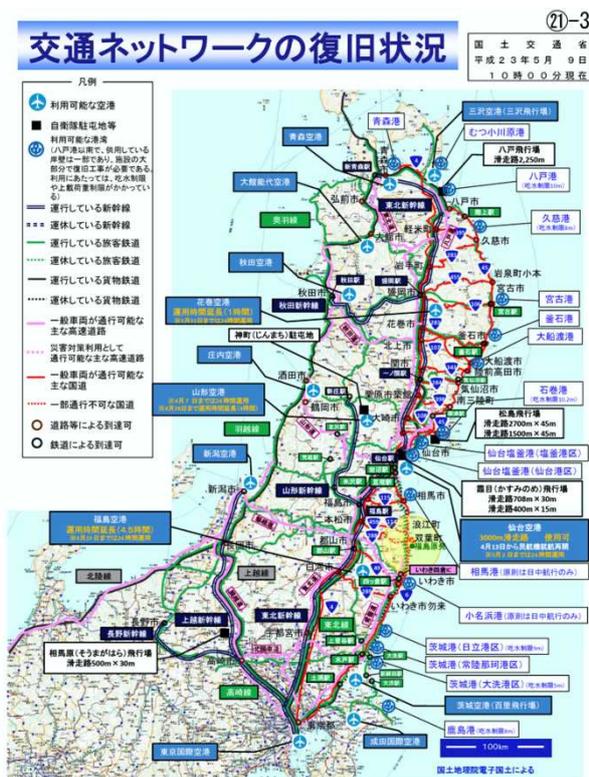
Figure 12 Recovery progress map (GSI 2011i)

Several kinds of thematic maps were also produced. One example is the recovery progress map (Figure 12). The purpose of the map is to show the status of recovery of major transport infrastructure (road, railway, port and airport) on a regular update basis. This map, which was developed collaboratively with GSI and relevant bureaux of MLIT, got publicity in a certain period. Another example is the evacuation zoning map (Figure 13). The government designated evacuation zoning areas around Fukushima nuclear power plant on 22 April 2011. Accordingly, GSI produced the map in collaboration with Cabinet Secretariat operation center and made it public. Geospatial information analysis and cartographic capability of GSI was effectively utilized to ensure information accessibility of the public.
